Manhole Inspection Summary

Manhole # S250__009MH

Insp Date: **4/4/08 11:47 AM**

Location Address: **1207 WARD ST.**

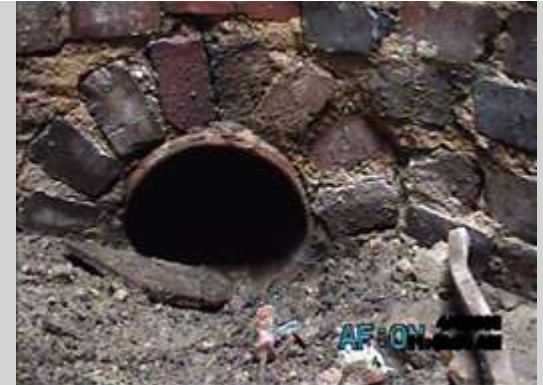
12 O'Clock Outflow

8 in. Circular Gravity Sewer
Pipe Out @ 12 O'Clock

Pipe Height: **8.4** (in.) Rod and Bar (Angled)

Pipe Material: **Clay** ☐ Pipe Lined

Infiltration: **None** Pipe Seal Cond: **Sound**
